Low dose-rate irradiation of RD53A Chip

- Low dose-rate irradiation setup in the pixel lab
- RD53A Chip irradiated with Kr-85 (60mCi, 7 rad/s) since September 2018

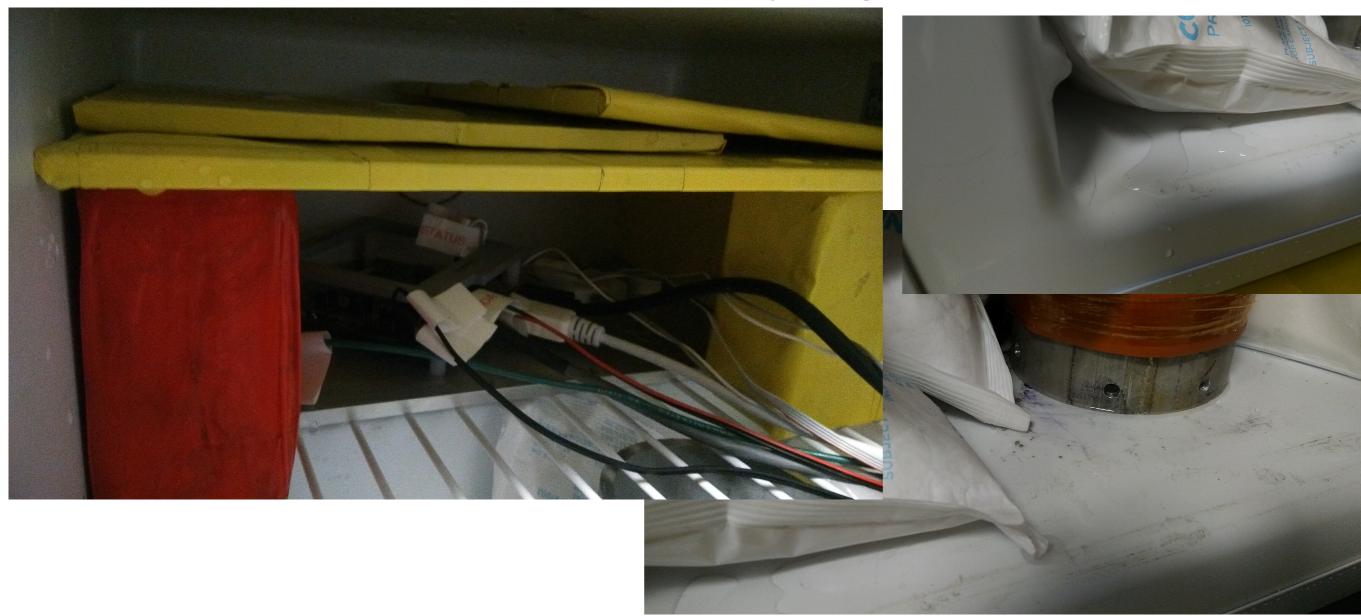
- On Tuesday, August 4 17:40 the power supply turned off
- Unable to configure the chip after multiple power-cycling
- Tried warming up (until 0 C) but still the same
- Kr-85 source taken out on Saturday, August 7 at 5:40

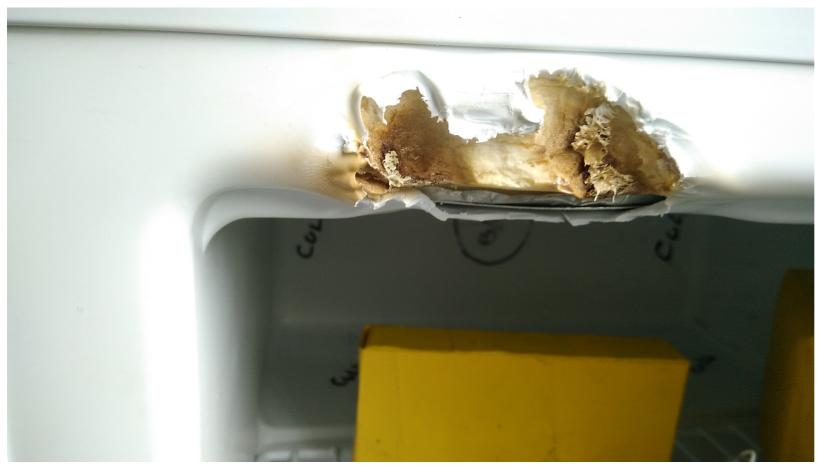
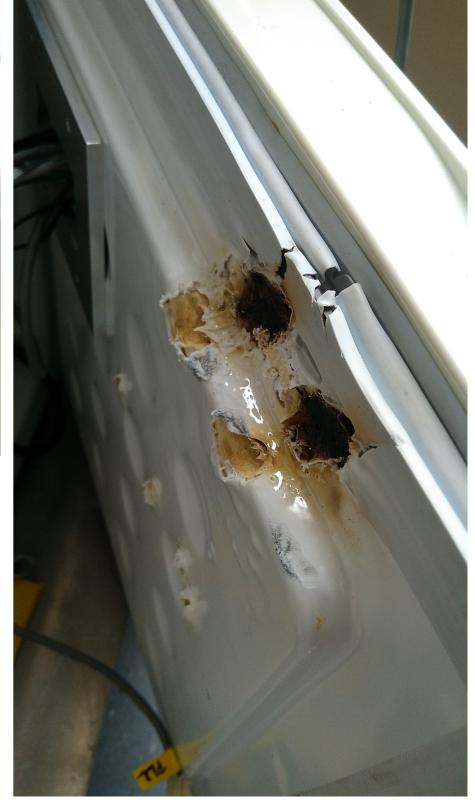
High humidity

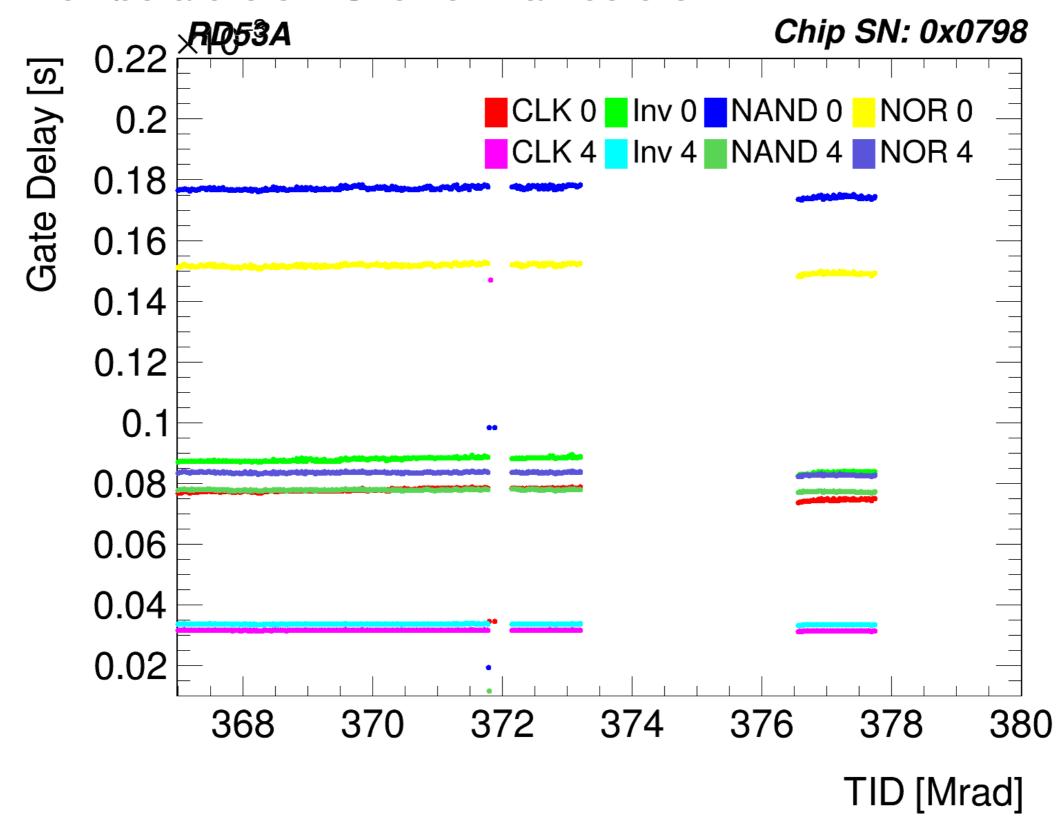
Temperature 0.7 C lower than before

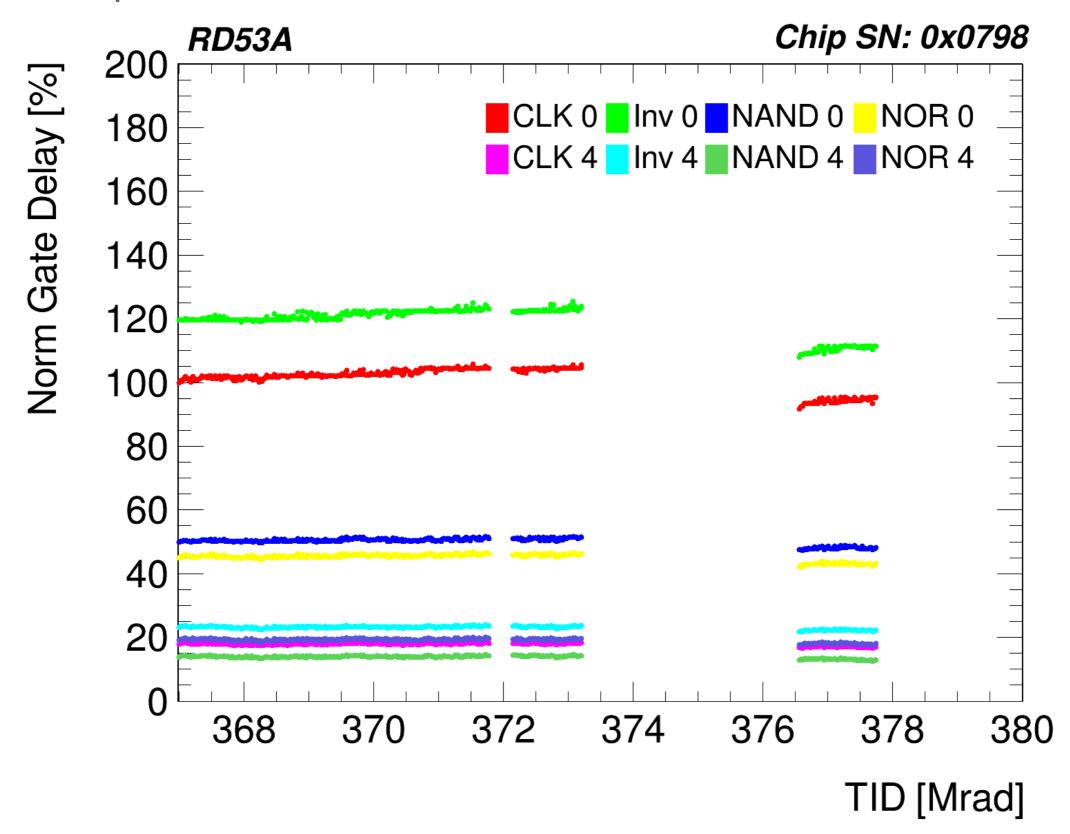
Temperature 0.7 C lower than before

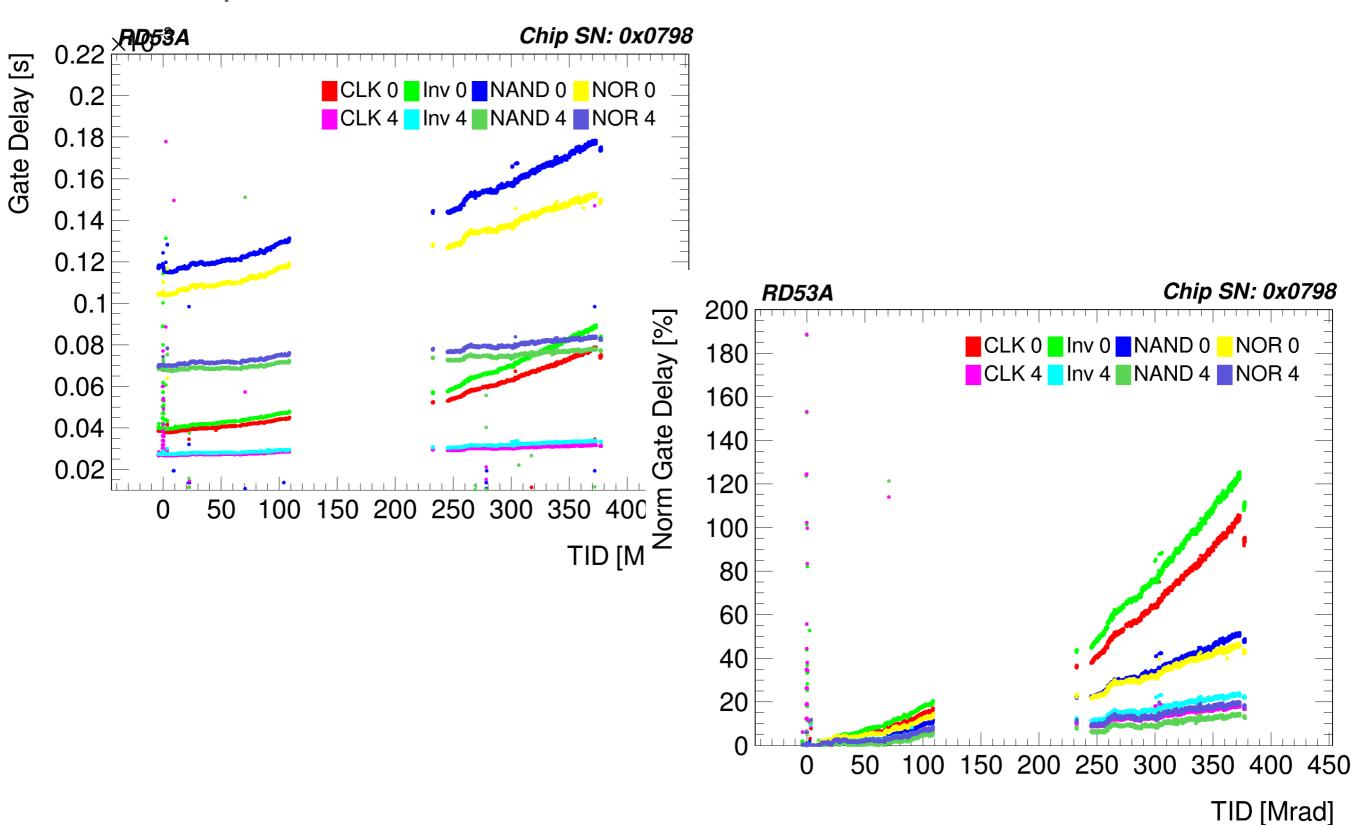
Temperature 0.7 C lower than before
