Fracturing due to Thermal Stress in ATLAS ITk Strip Modules:

WHY IT HAPPENED

AND HOW TO PREVENT IT FROM HAPPENING TO YOU.

Anne Fortman on behalf of the ATLAS ITk Collaboration

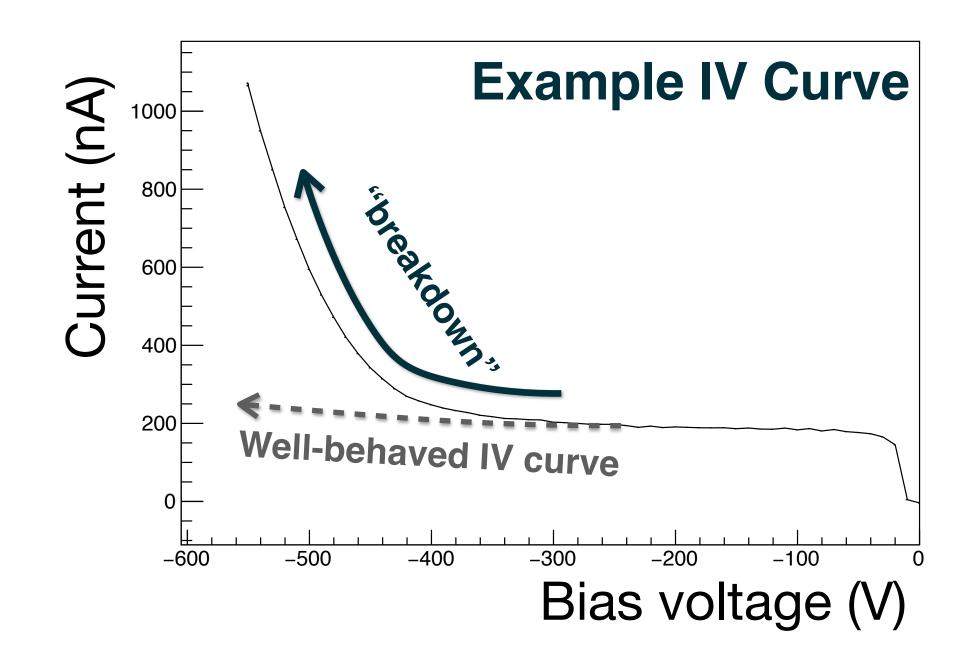
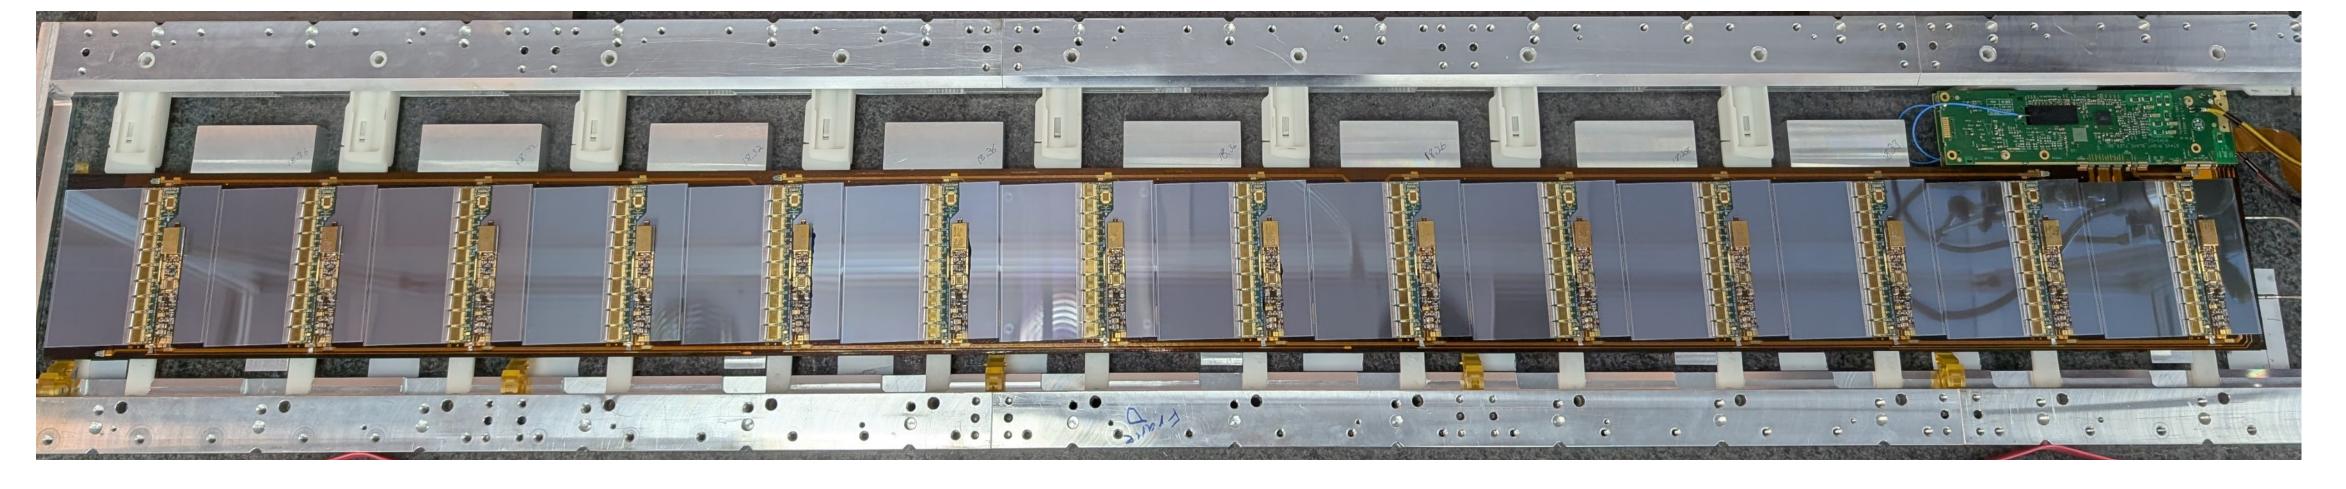
Problem detected!

- Thermal-cycled prototype support structures [-35°C, 20°C] as part of quality control
- Post-thermal-cycling, could no longer apply HV to bias some sensors...

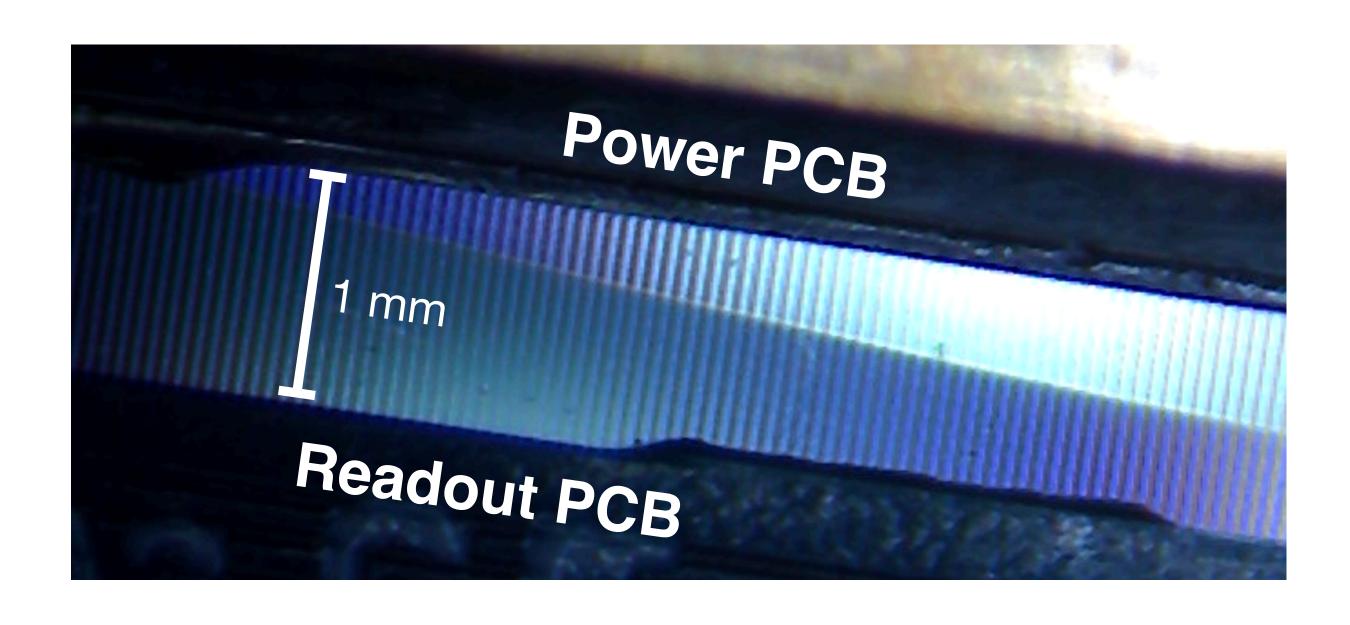
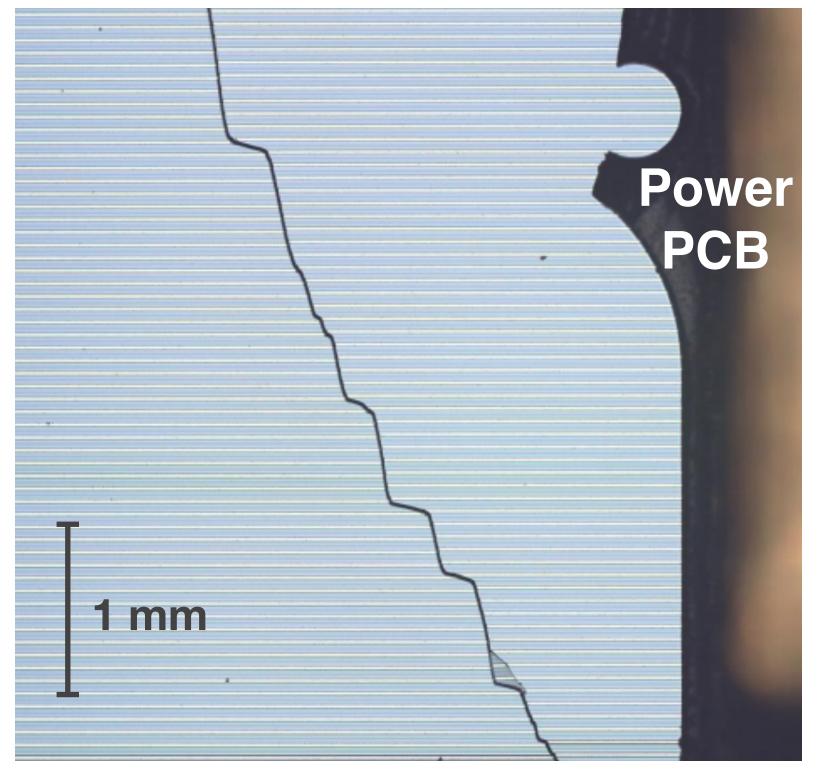
Cracked Sensors!

Just before start of module production, in spring 2023, identified the issue: cracks!

No prior indications of cracks during thermal cycling of individual modules

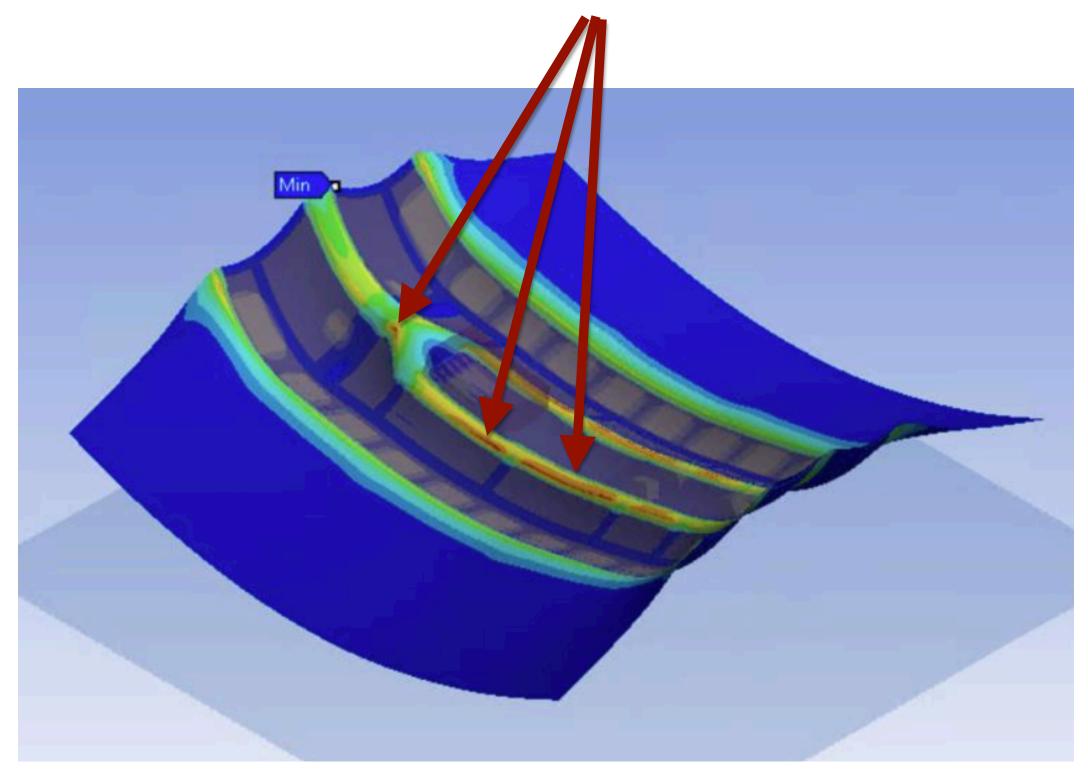
New FEA simulation of module stress

- Checked for problematic stress with finite-element thermo-mechanical model
- Original model may have been too coarse to capture local stress peaks
 - New simulation shows that details of epoxy glue patterns matter

Localised stress peaks ~150 MPa

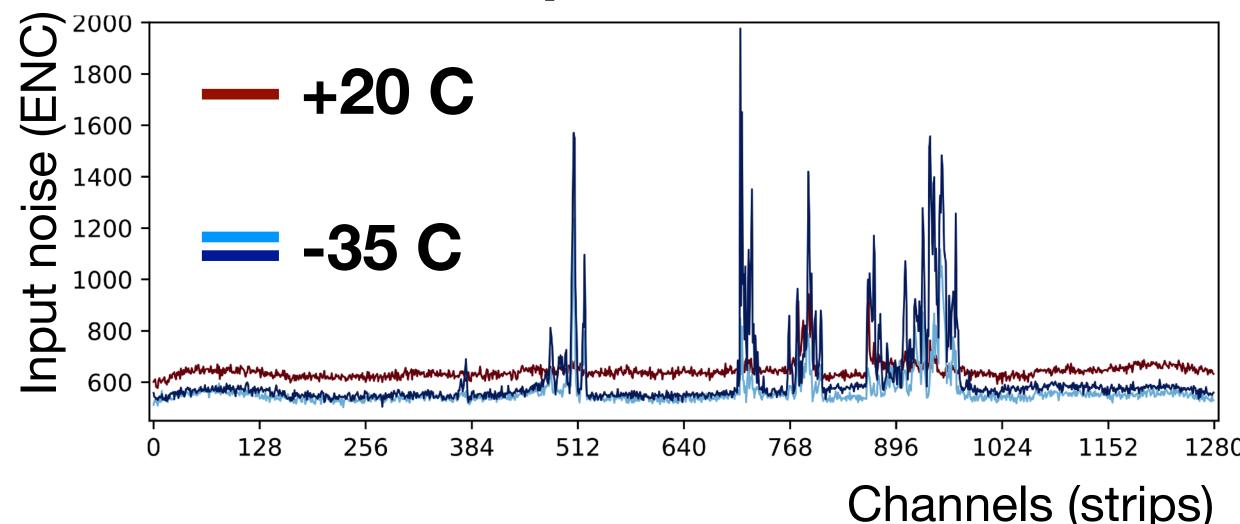
Example of Cold Noise

- Many design changes since original modelling
 - E.g. epoxy changed multiple times: discontinued by vendors, attempt to mitigate issues (cold noise)
- Simulation not updated due to lack of personpower

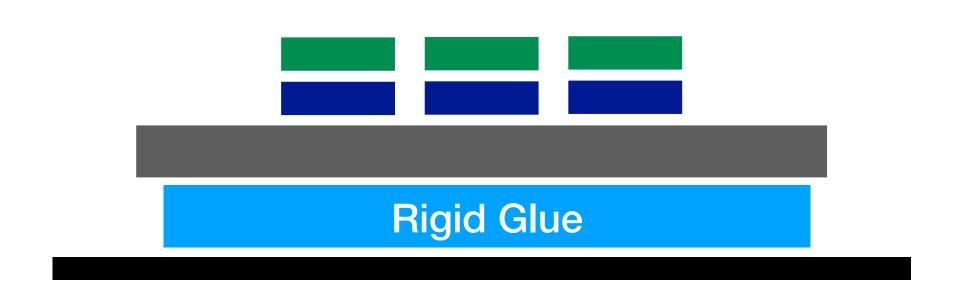
Least-invasive mitigation strategy: Replace soft loading glue with rigid glue

- Expected up to 50% reduction in thermal stress
- Did not sufficiently reduce the cracking rate (~60% in the barrel above -55°C)

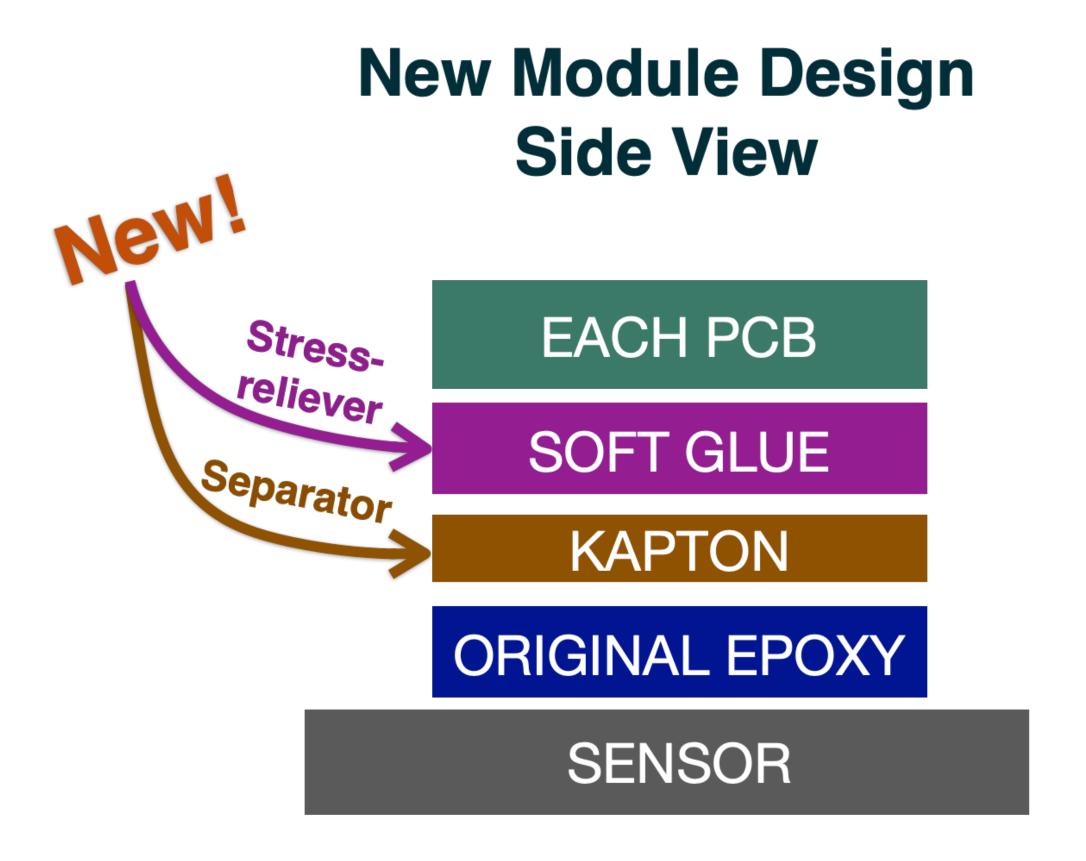
The New Design

- Add layer of soft glue to underside of each PCB
 - Absorbs stress, PCBs can contract without affecting sensor
- Strategic choice of soft glue:
 - Already in use to load modules to support structures
 - Shown in past cold noise studies to eliminate cold noise (but causes electrical problems if directly contacting the sensor)
- Promising: simulation predicts up to 10x decrease in sensor stress!

Soft glue = Dow SE 4445 thermally conductive gel ~10,000x softer than original epoxy

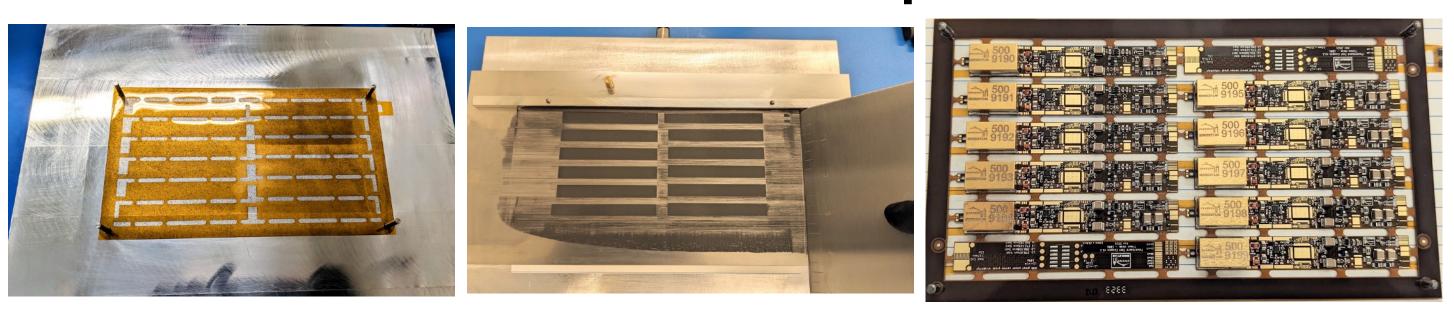
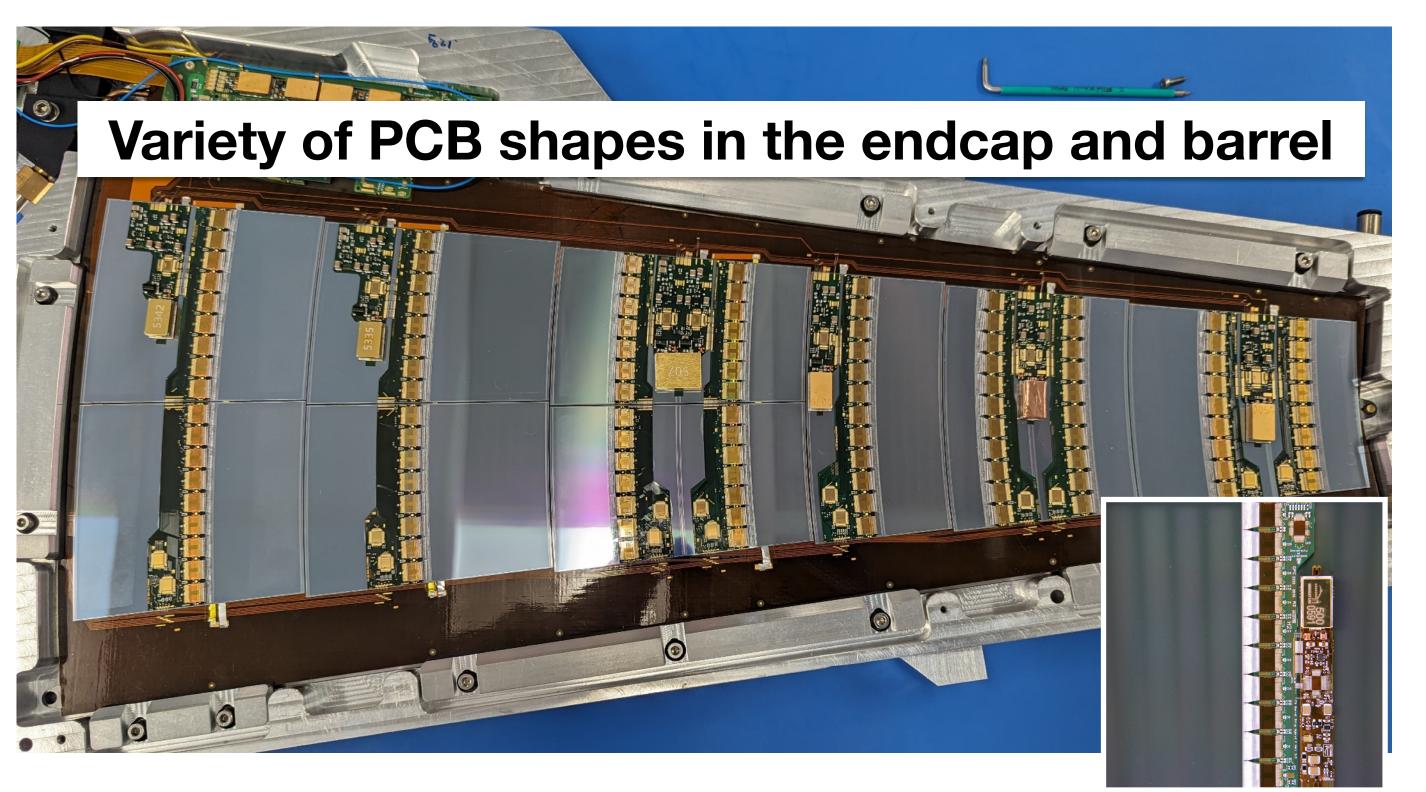
Mass lamination of barrel power PCBs

- Minimize disruption to production by adding new layers to PCBs at selected sites
 - Feed laminated PCBs back into module production chain, assemble modules as before
- Must laminate over 40,000 PCBs at production rates
 - Developed new tooling/procedures to mass-laminate PCBs
 - Needed custom procedures for different PCB types due to multiplicity of designs

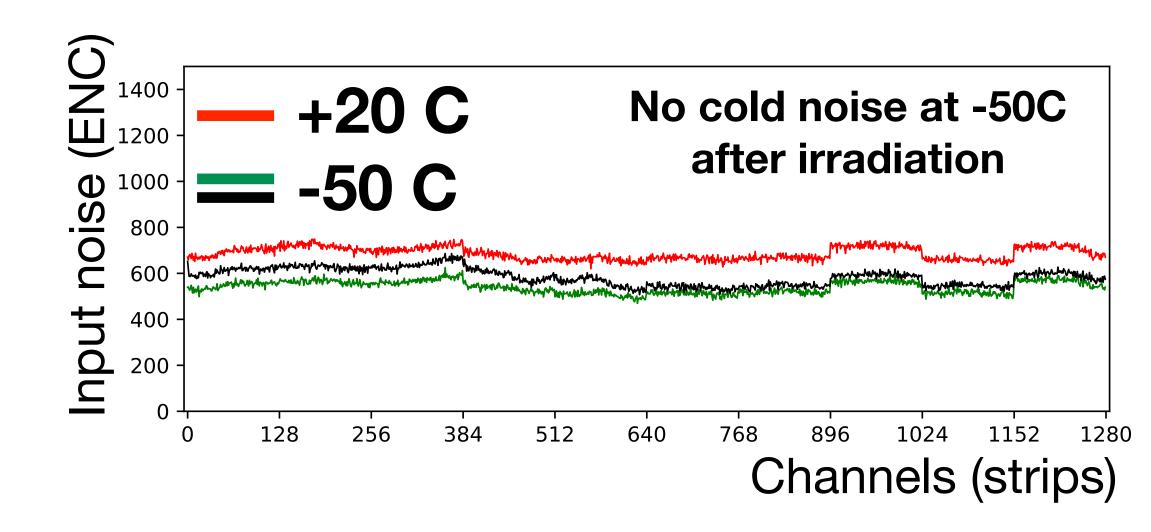
Highlight: new design solved cold noise!

Vestiges of cold noise eliminated in newdesign modules, even at extra-cold temps and after irradiation

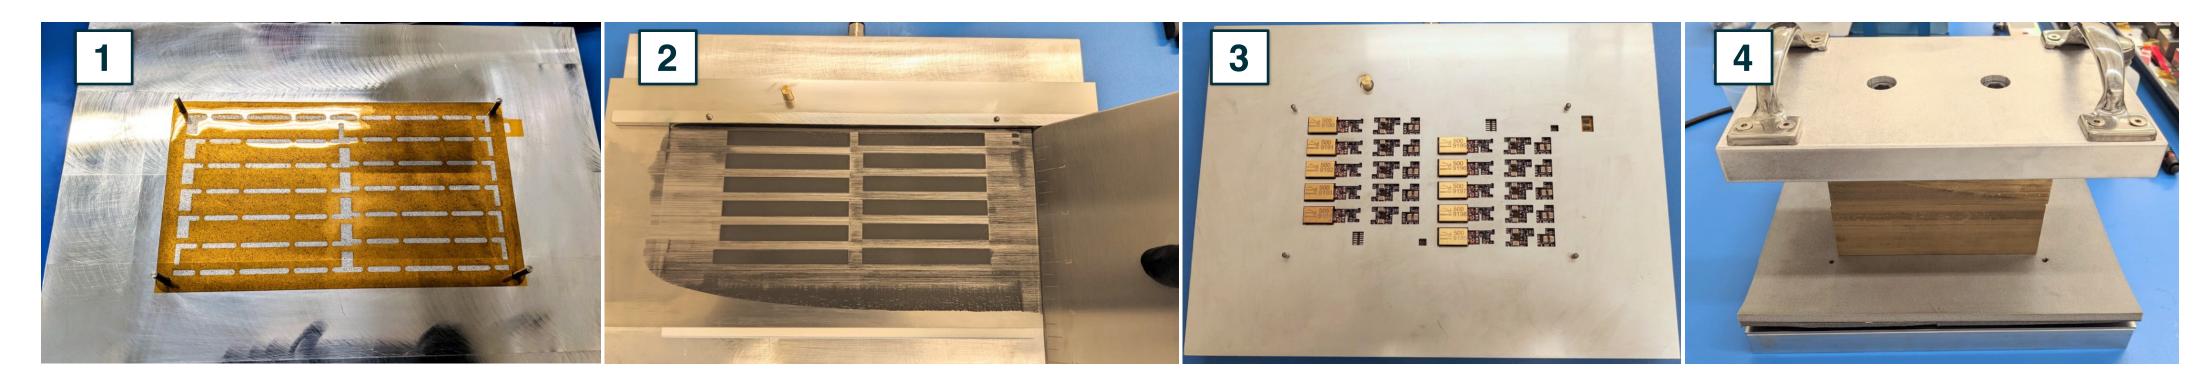
Barrel Power PCB Lamination

Hold thin (50µm) kapton flat with a metal foam vacuum tool.

Stencil the soft glue onto the kapton.

Align the PCB array and press on non-sensitive areas.

Cure under weight. Glass beads in the glue set the glue layer thickness.

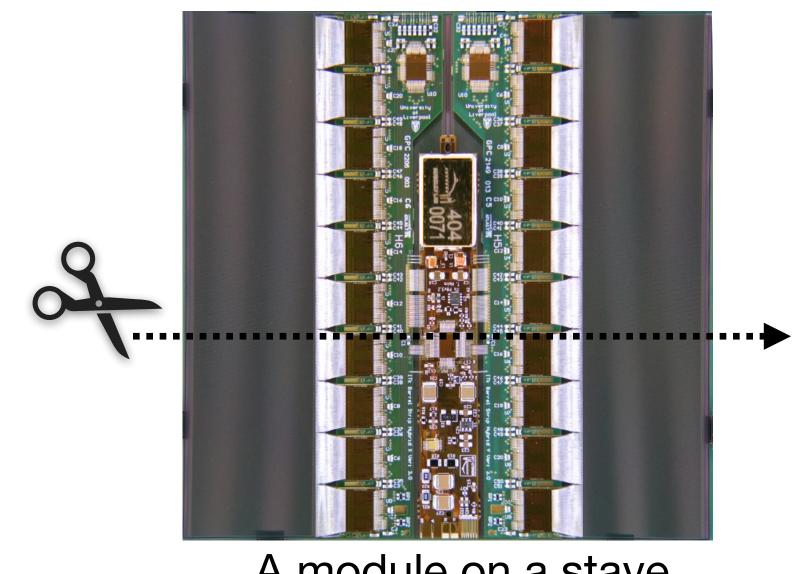
A module on a stave

Mostly copper Loctite Eccobond F112 Silicon Dow SE 4445 Carbon-fiber

PCBs Stiff Glue Sensor **Soft Glue** Stave
