Low dose-rate irradiation of RD53A Chip

- Low dose-rate irradiation setup in the pixel lab
- RD53A Chip irradiated with Kr-85 (60mCi, 7 rad/s) since September 2018

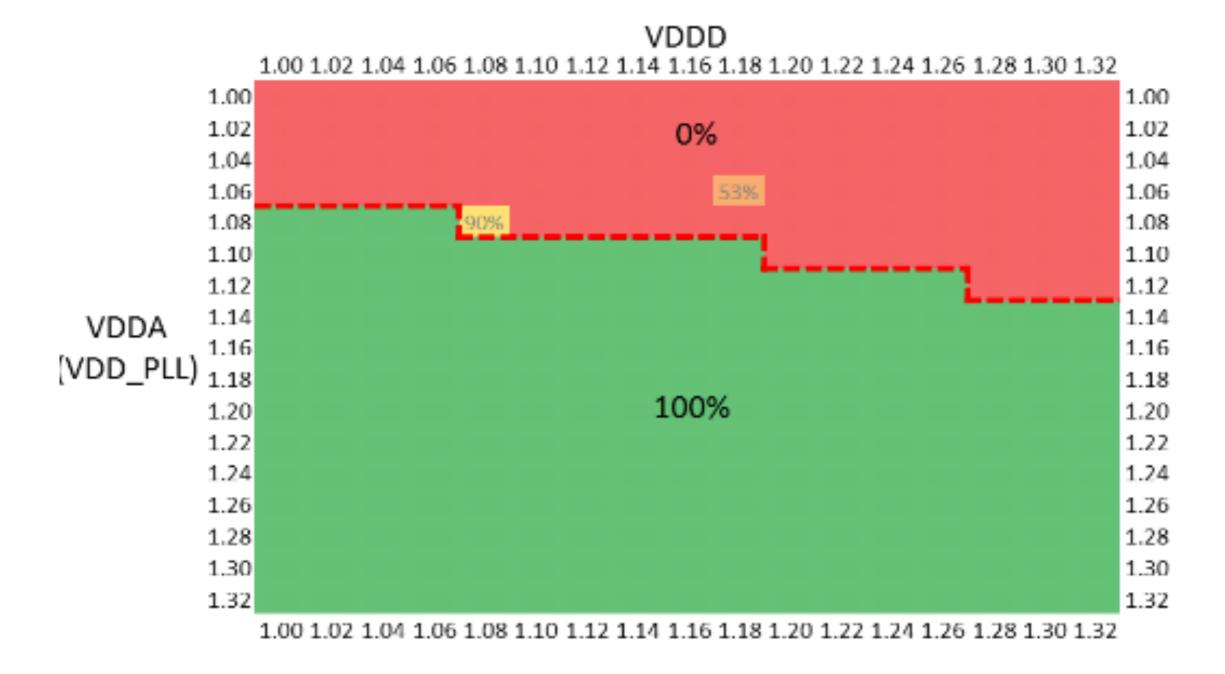
- On Tuesday, August 4 17:40 the power supply turned off
- Unable to configure the chip after multiple power-cycling
- Tried warming up (until 0 C) but still the same
- Kr-85 source taken out on Saturday, August 7 at 5:40 and put in a storage freezer
- Chip operated in Climate Chamber at -30C and tested
 - Direct powering
 - LDO with separate PLL power
- Chip put back in the freezer with a source on on Tuesday, August 11 at 15:46

What happened?
