YARR Firmware Tutorial

Diced ITkPixV2 Readout Chips

Luc Le Pottier, Timon Heim

Lawrence Berkeley National Lab
January 14th, 2025

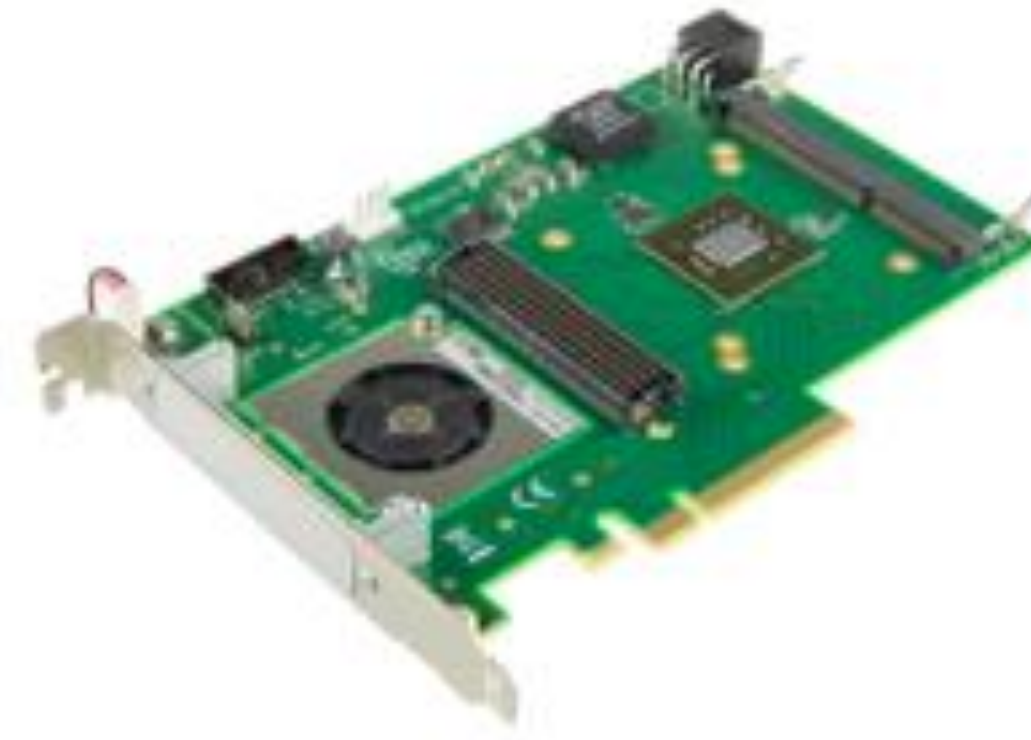
Trenz TEF-1001/2

- YARR uses [custom PCIe firmware](#), on off-the-shelf FPGAs
- Recommended, best understood FPGA is **TEF-1001 / TEF-1002**
- [YARR website](#) contains documentation regarding setup, flashing firmware, etc.
- **What is SPEC?**
 - Simple (cheap)
 - PCIE (how we communicate with PC)
 - FMC (how we communicate with FEs)
 - Carrier

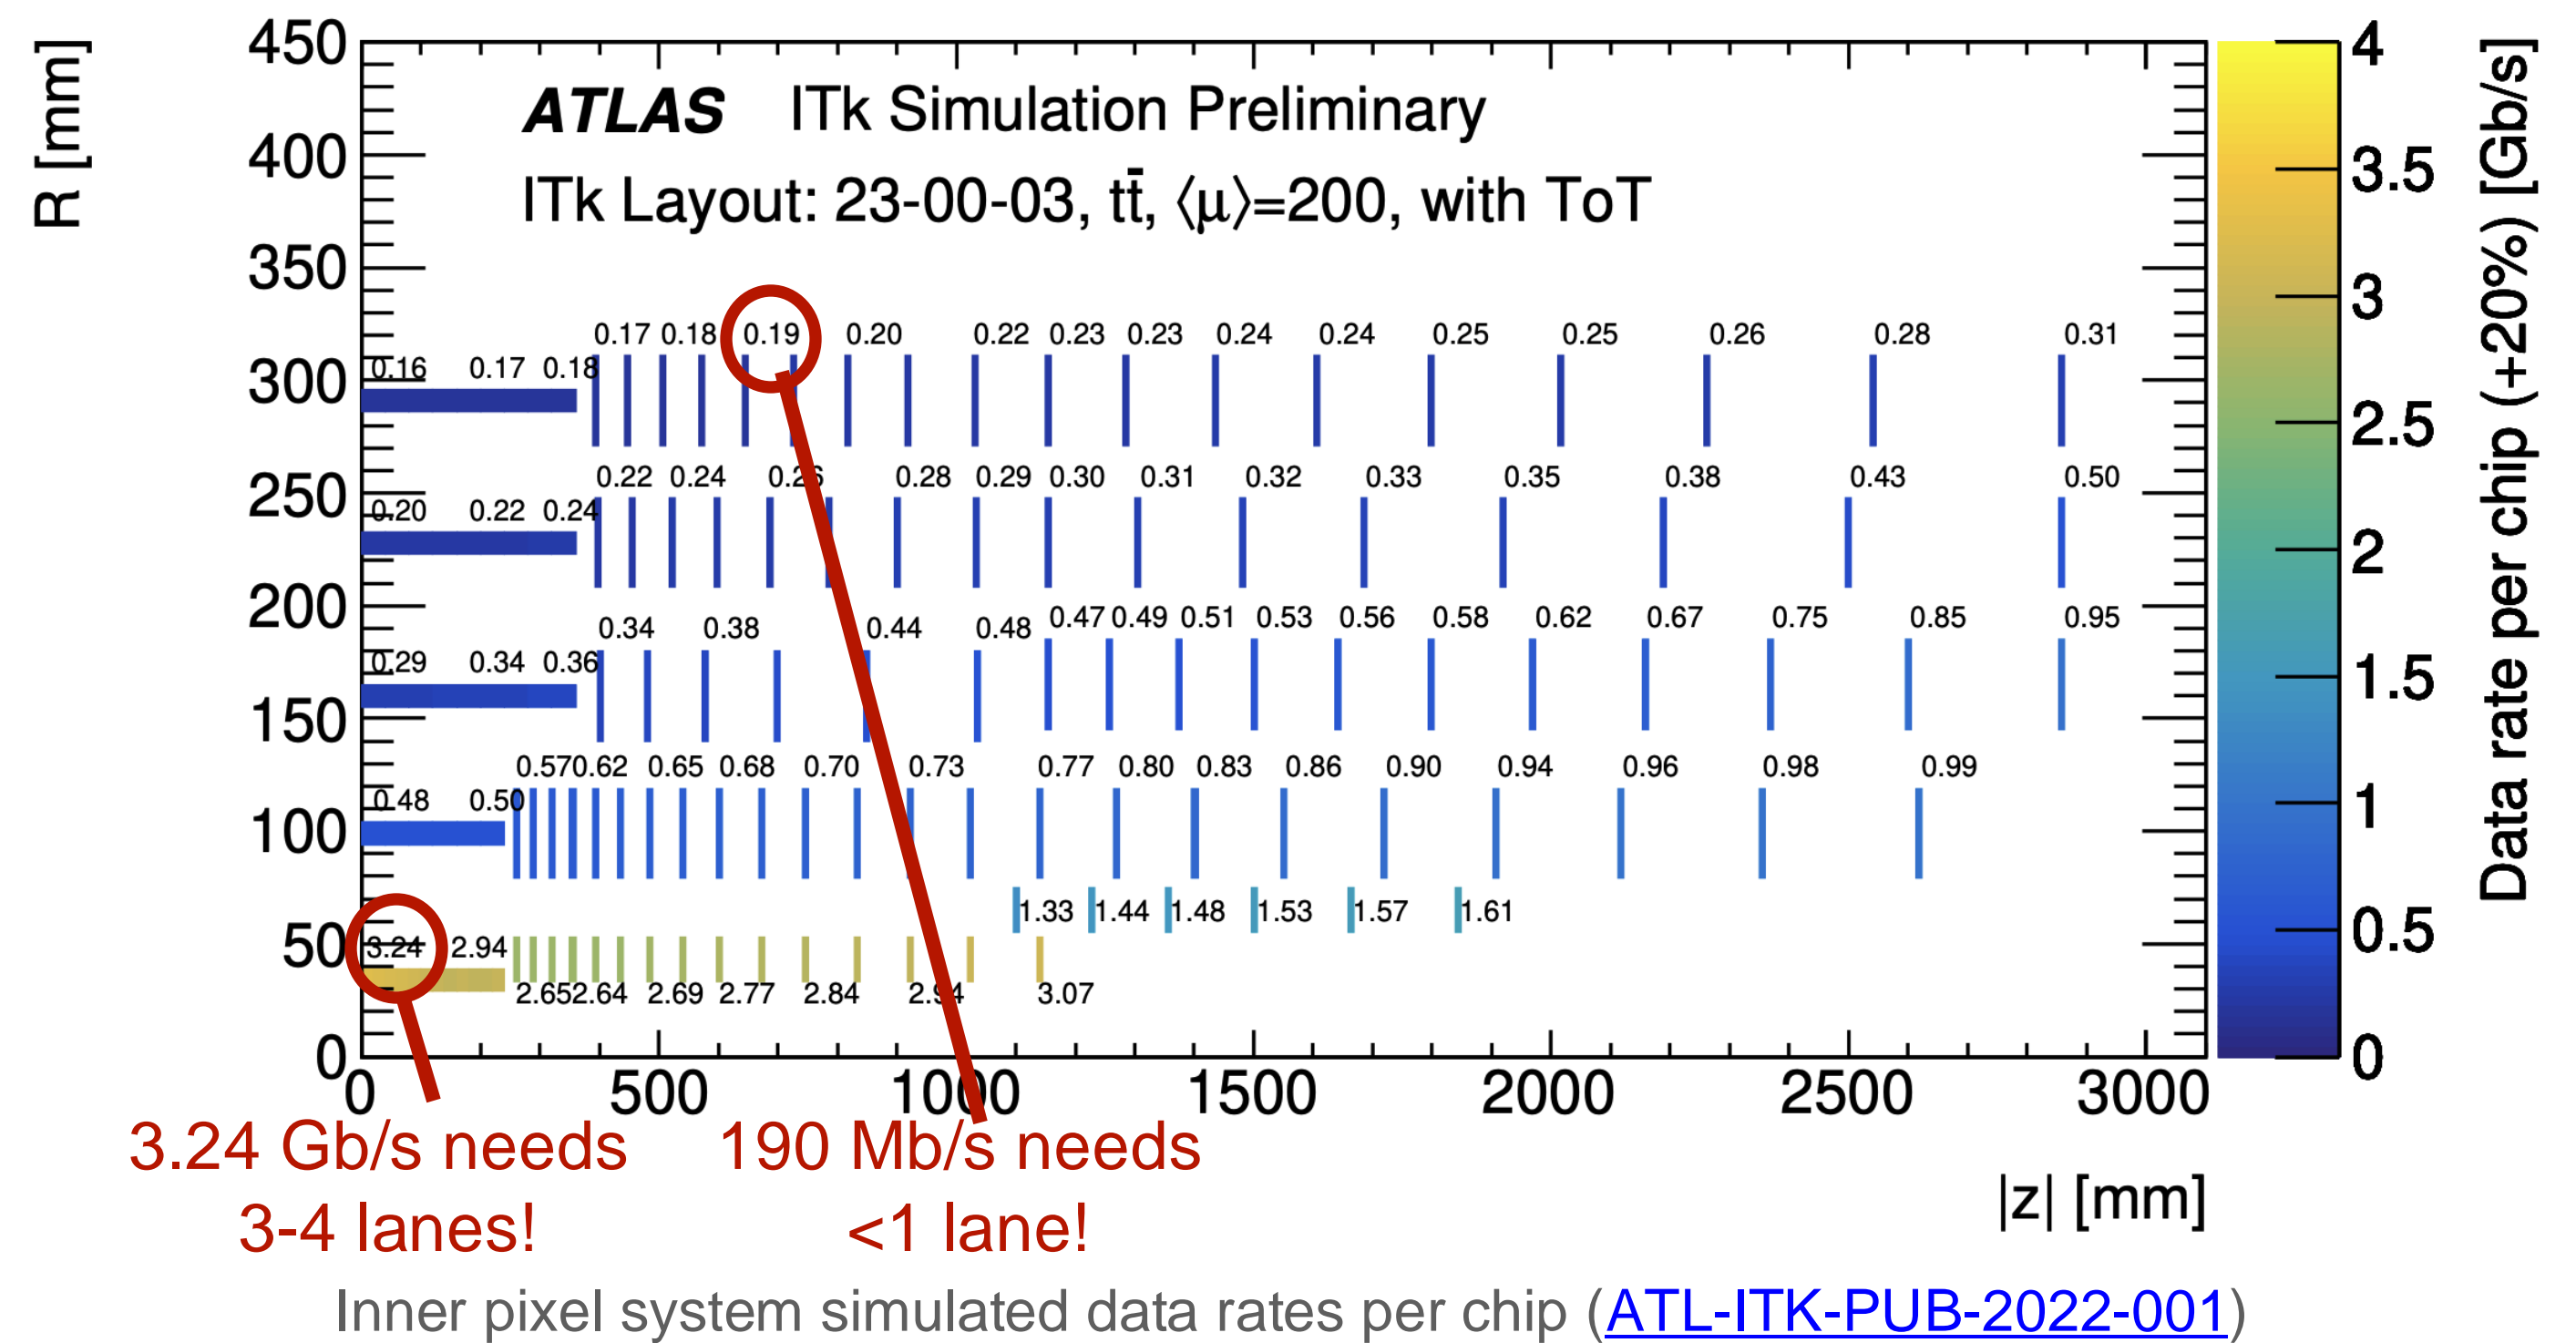
Lanes and Data

- Rd53 designed with large range of operating conditions in mind
- In particular: **20x difference** in bandwidth requirement between innermost / outermost layer chips!
- But, increased readout bandwidth = more power.. how to minimize?
- 4 readout channels per chip, called **lanes**
- Maximum of **1.28 Gbps** on each lane
- Lanes will be disabled if not needed
- **Examples:**
 - Outer layer quad with 160 Mb/s/chip needs $4 \times 160 = 640$ Mbps, fits on a single lane (can be combined with **data merging**)
 - Inner layer quad with 3.24 Mb/s/chip needs **3-4 lanes per chip** (4 to hit S.F.)

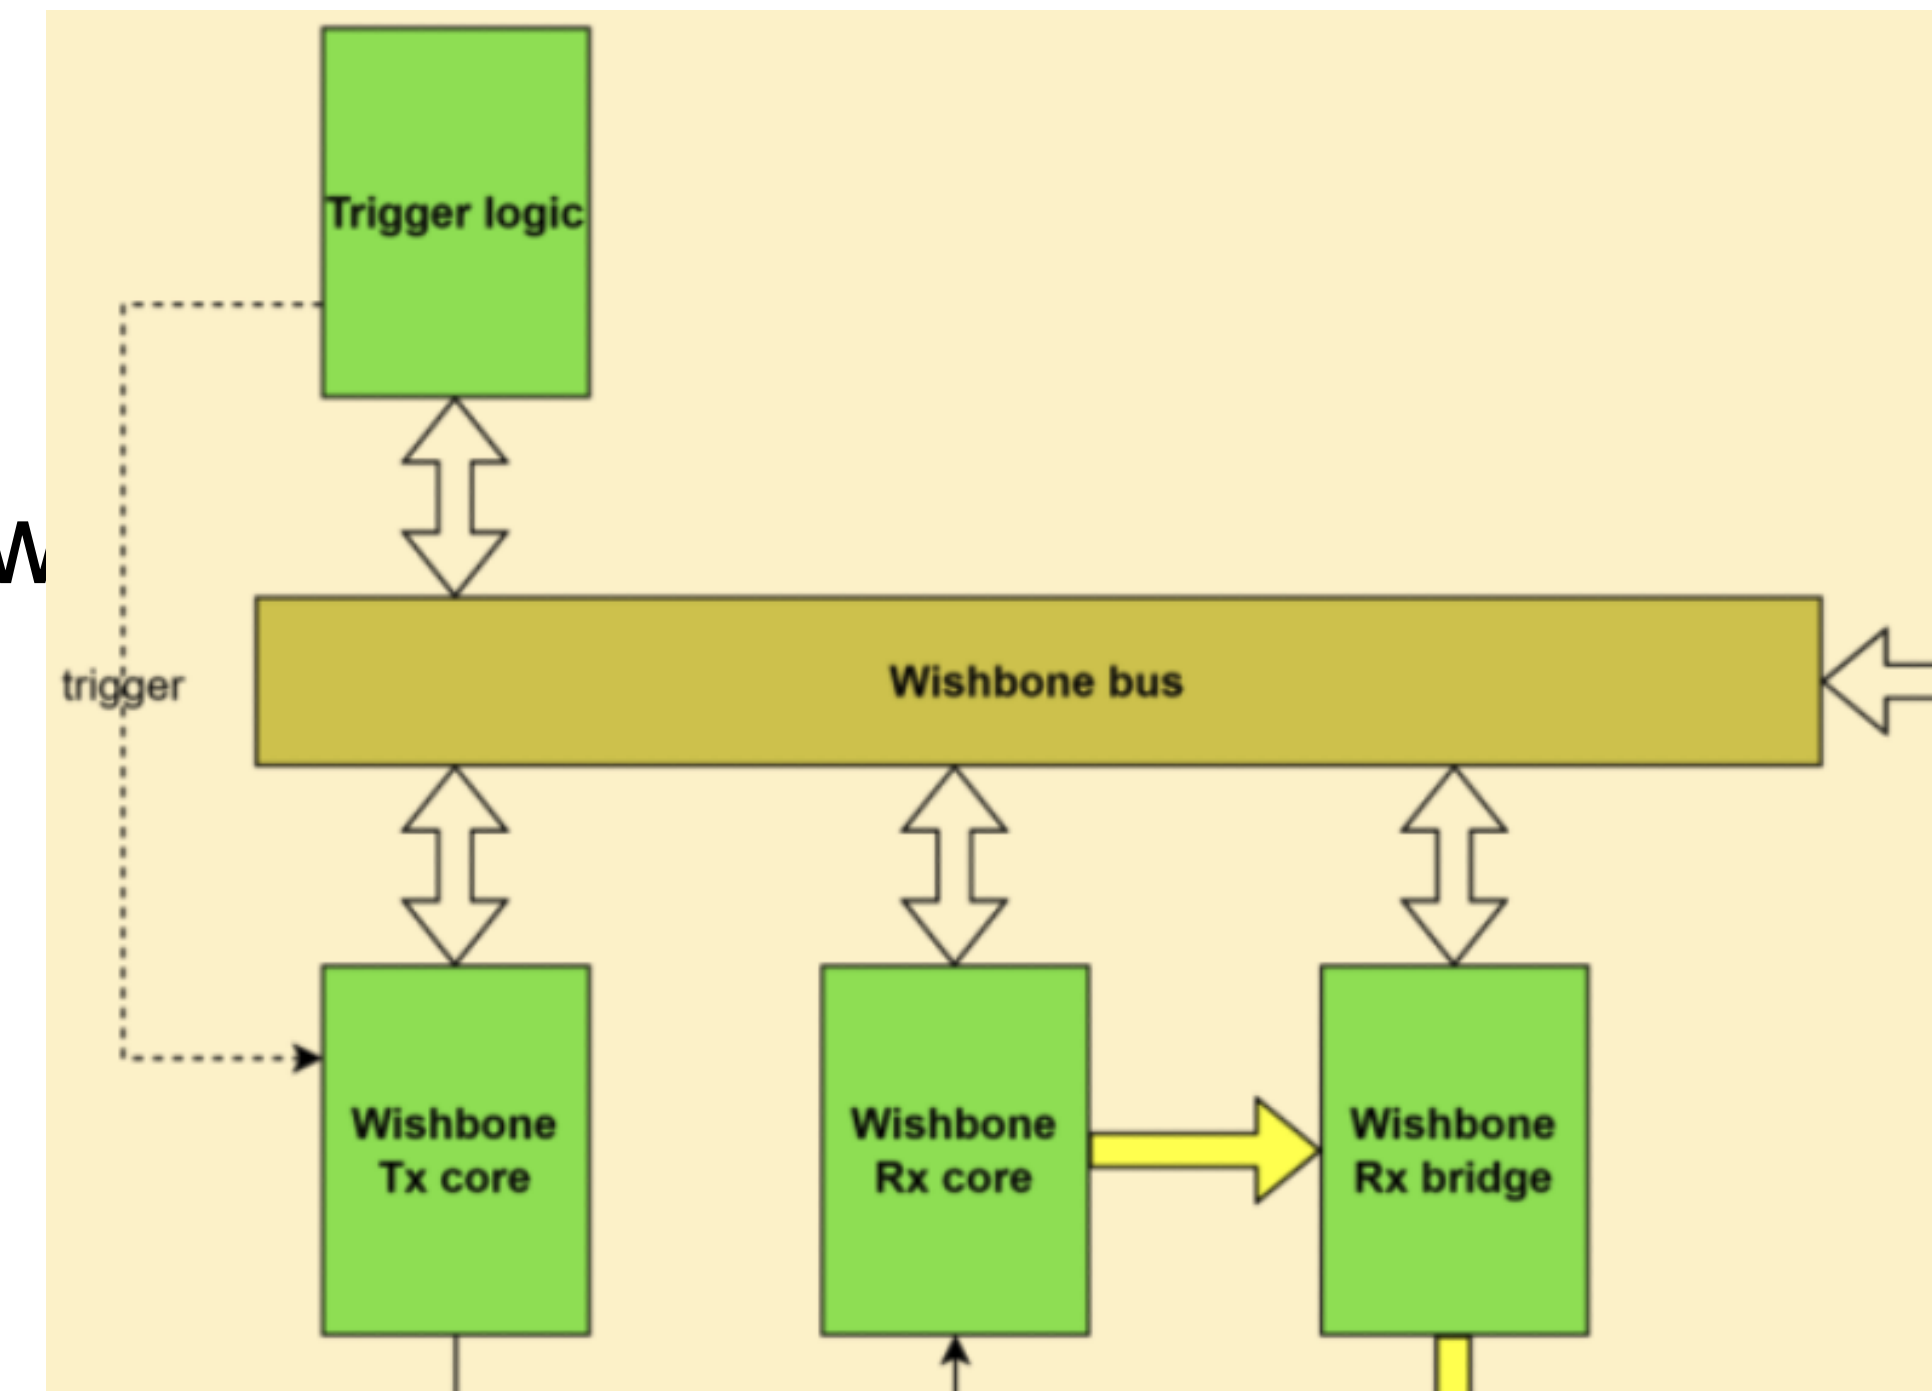
Configuration and Reset

Firmware uses the [wishbone interconnect architecture](#)

- Provides a way for different **IP cores** (chunks of firmware)
- I.e. **PCIe** and **FIFO** implementations

Wishbone buses provide

- **Firmware config** registers
- Local “soft” **resets**
- Block RAM transfers to PCIe

Configuration for FW typically goes through wishbone

- Rule of thumb 1: files with the suffix “**wb**” have a wishbone interface
 - This means they can easily be modified to take new configuration parameters
- Rule of thumb 2: firmware configuration comes from the **controller config file** in YARR: “-r”

```
serdes_1_to_8_idelay_ddr.vhd
wb_rx_bridge.vhd
wb_rx_core.vhd
```

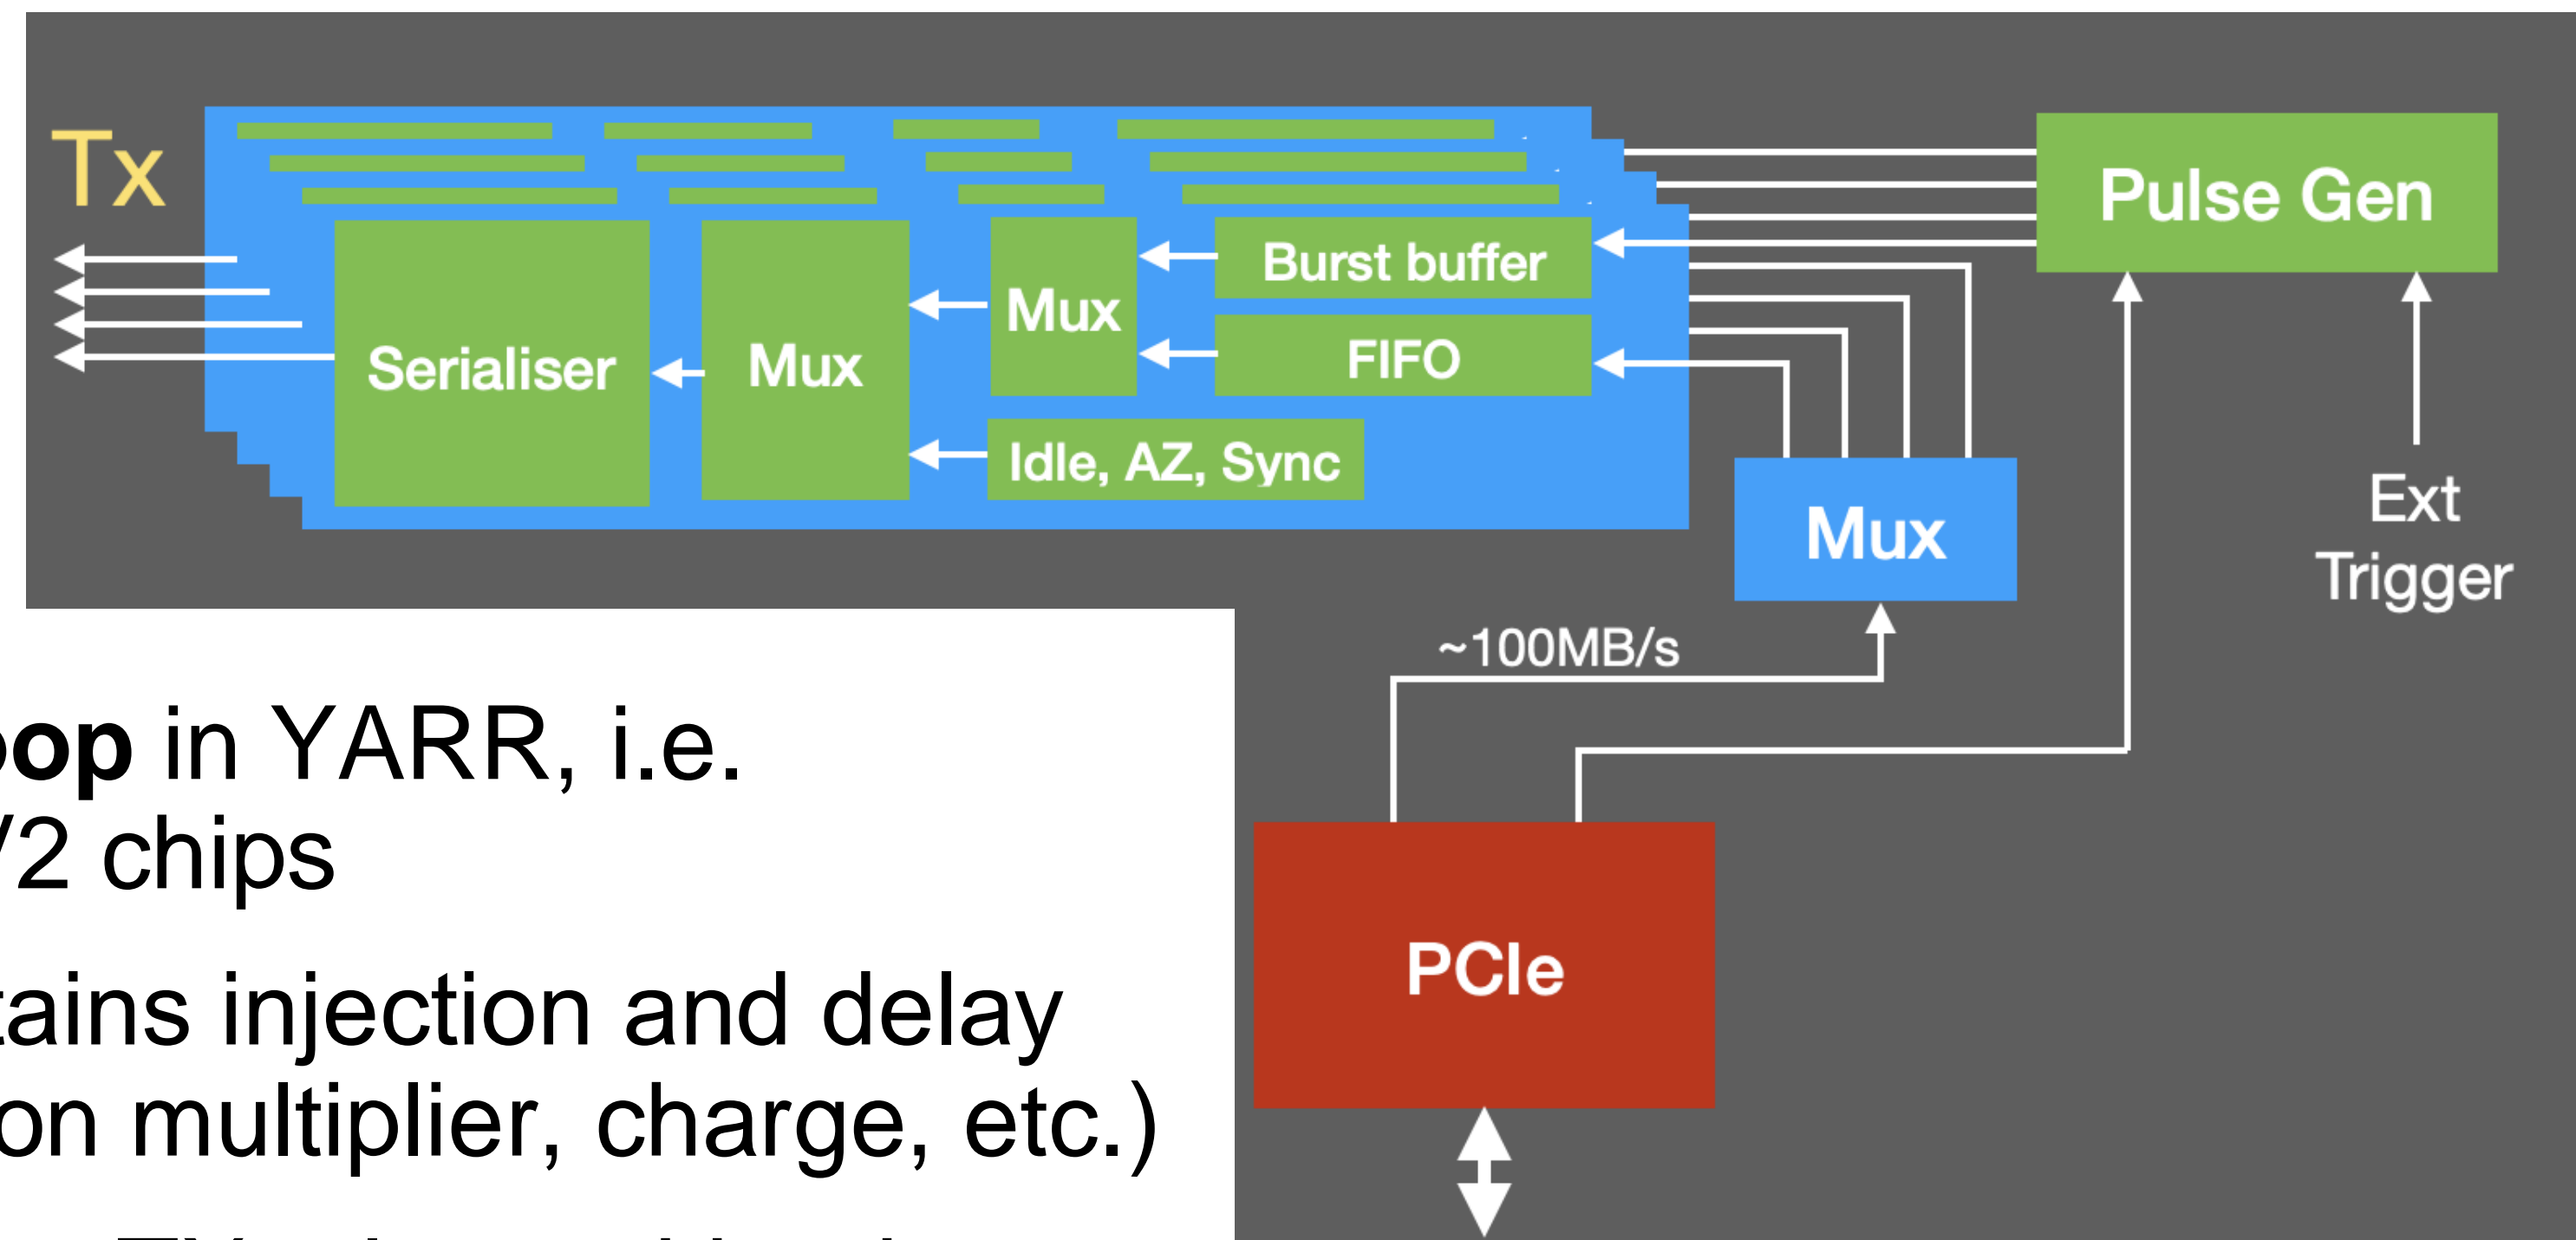
Triggering

For typical scans...

- Triggers are built in **<FE>TriggerLoop** in YARR, i.e. `ltpixV2TriggerLoop.cpp` for ITkPixV2 chips
- 32 bit “trigger word” that is built contains injection and delay commands for the chip (dependent on multiplier, charge, etc.)
- This word is sent via **wishbone** to the TX, along with other information about target scan **frequency**, **duration**, number of **iterations**, etc.

In the FPGA...

- Pulse generator + trigger logic blocks begin cycling through the trigger word buffer repeatedly, at the specified frequency and for the specified duration/iteration number
- Can also use **external triggers** by enabling them properly from software
 - Trigger tags: new addition, built in firmware as we go
- Serializer sends commands to all enabled FEs simultaneously

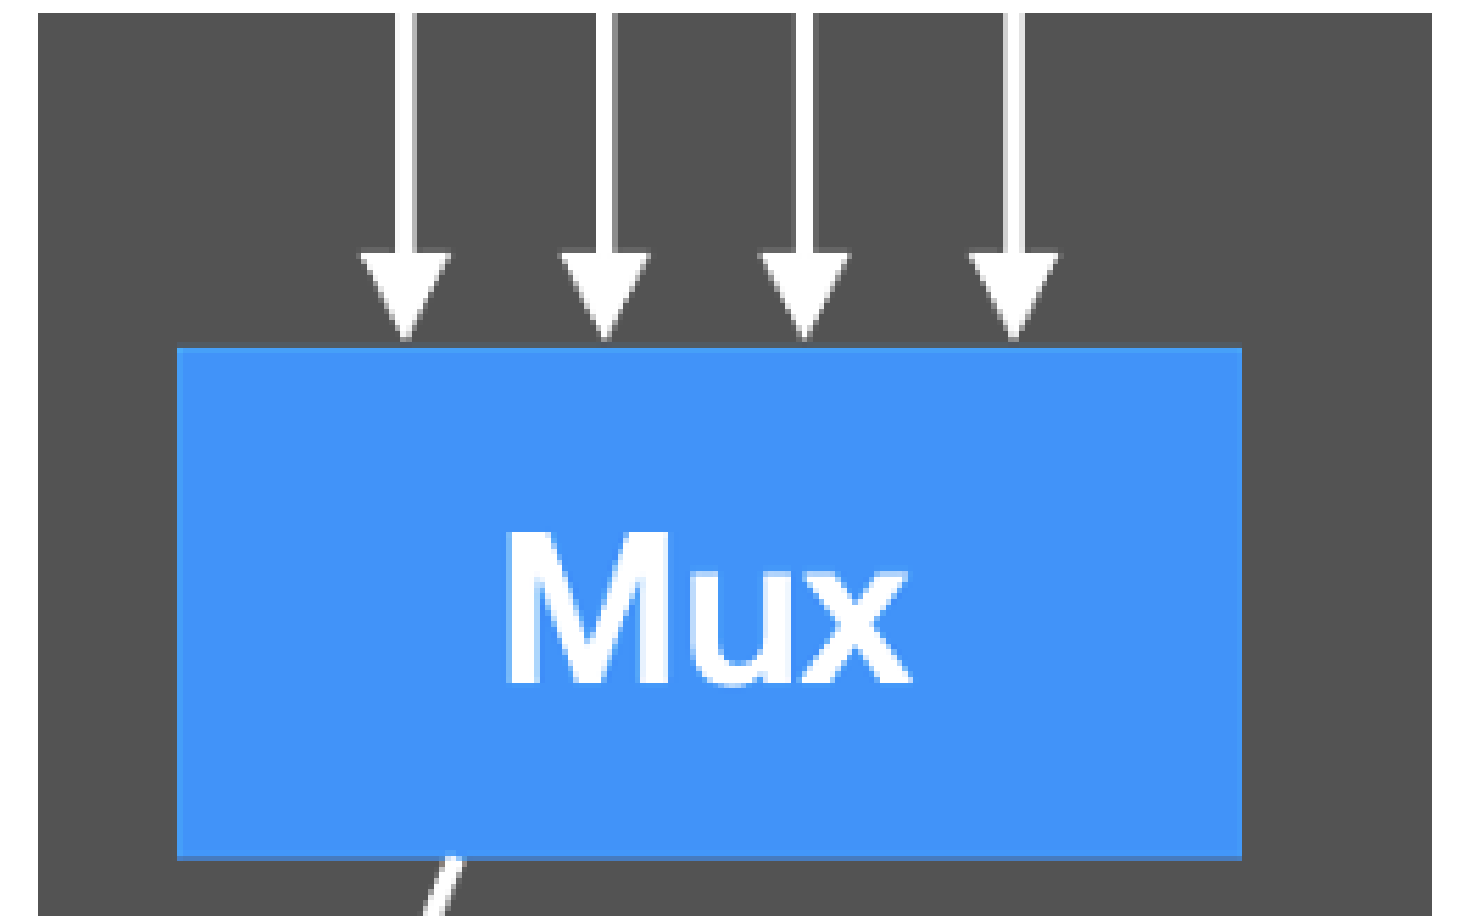
Channel Multiplexer

- Each of the four **channels** (corresponding to ports on the Ohio card) go to a **round-robin arbiter**
 - This block multiplexes the data into a single stream
 - Since different channels have different volumes of data, need a way to decide on which order to add them to the final output stream as they are coming in
 - It is also a system bottleneck: 160MHz clock limits the data rate to $160 \times 64 = \mathbf{10.24Gbps}$, lower than the 19.86Gbps previously
 - (FW upgrade to make this clock 320 MHz, but it is complicated)
- **Possible issues:**
 - [Empty words added during arbitration](#), for channels without data -> blows up data rate
 - Can occur during self-trigger scan if there are very **noisy pixels**
 - In particular: “noisy” from noisescan != “noisy” in selftrigger scan... hard to mask with a typical noise scan.

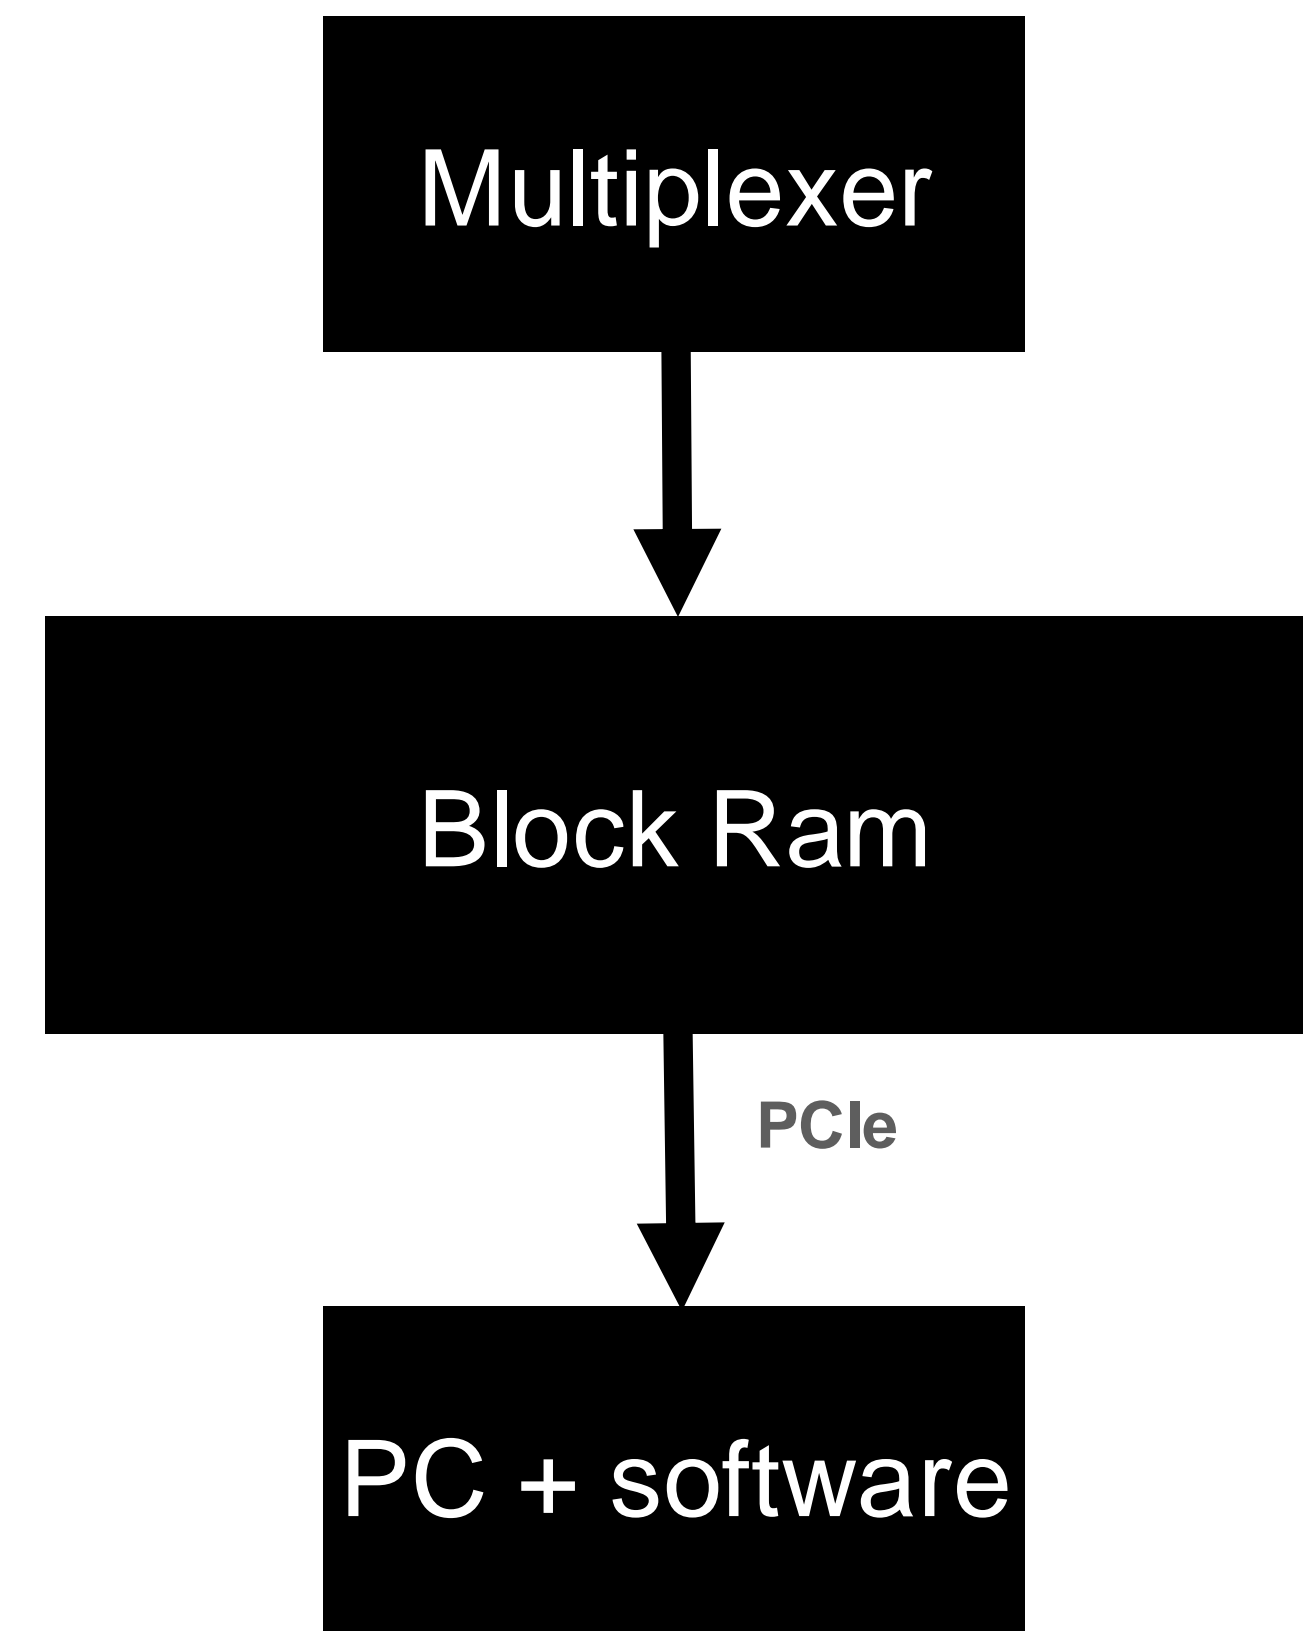
Block RAM

Multiplexed data for all **four channels**, each with up to **four lanes**, is passed to the **Block RAM (BRAM)**

- 64 rows by 16 columns of 18kb RAM blocks = 18 Mb of memory
- Batches data for fast block transfer to PC over PCIe

- If **data in** > **data out** of the block ram, we will start to overwrite data that has not been read out
- This can happen when...
 - We have a very high data rate (**data in** is fast)
 - We have a very slow PC (**data out** is slow)
- We implemented a [throttle mechanism](#) for the BRAM, which helps during FPGA-triggered scans, but:
 - Cannot throttle **self-trigger** scans
 - Does not cover case where **PC reads** stop for a “long” time

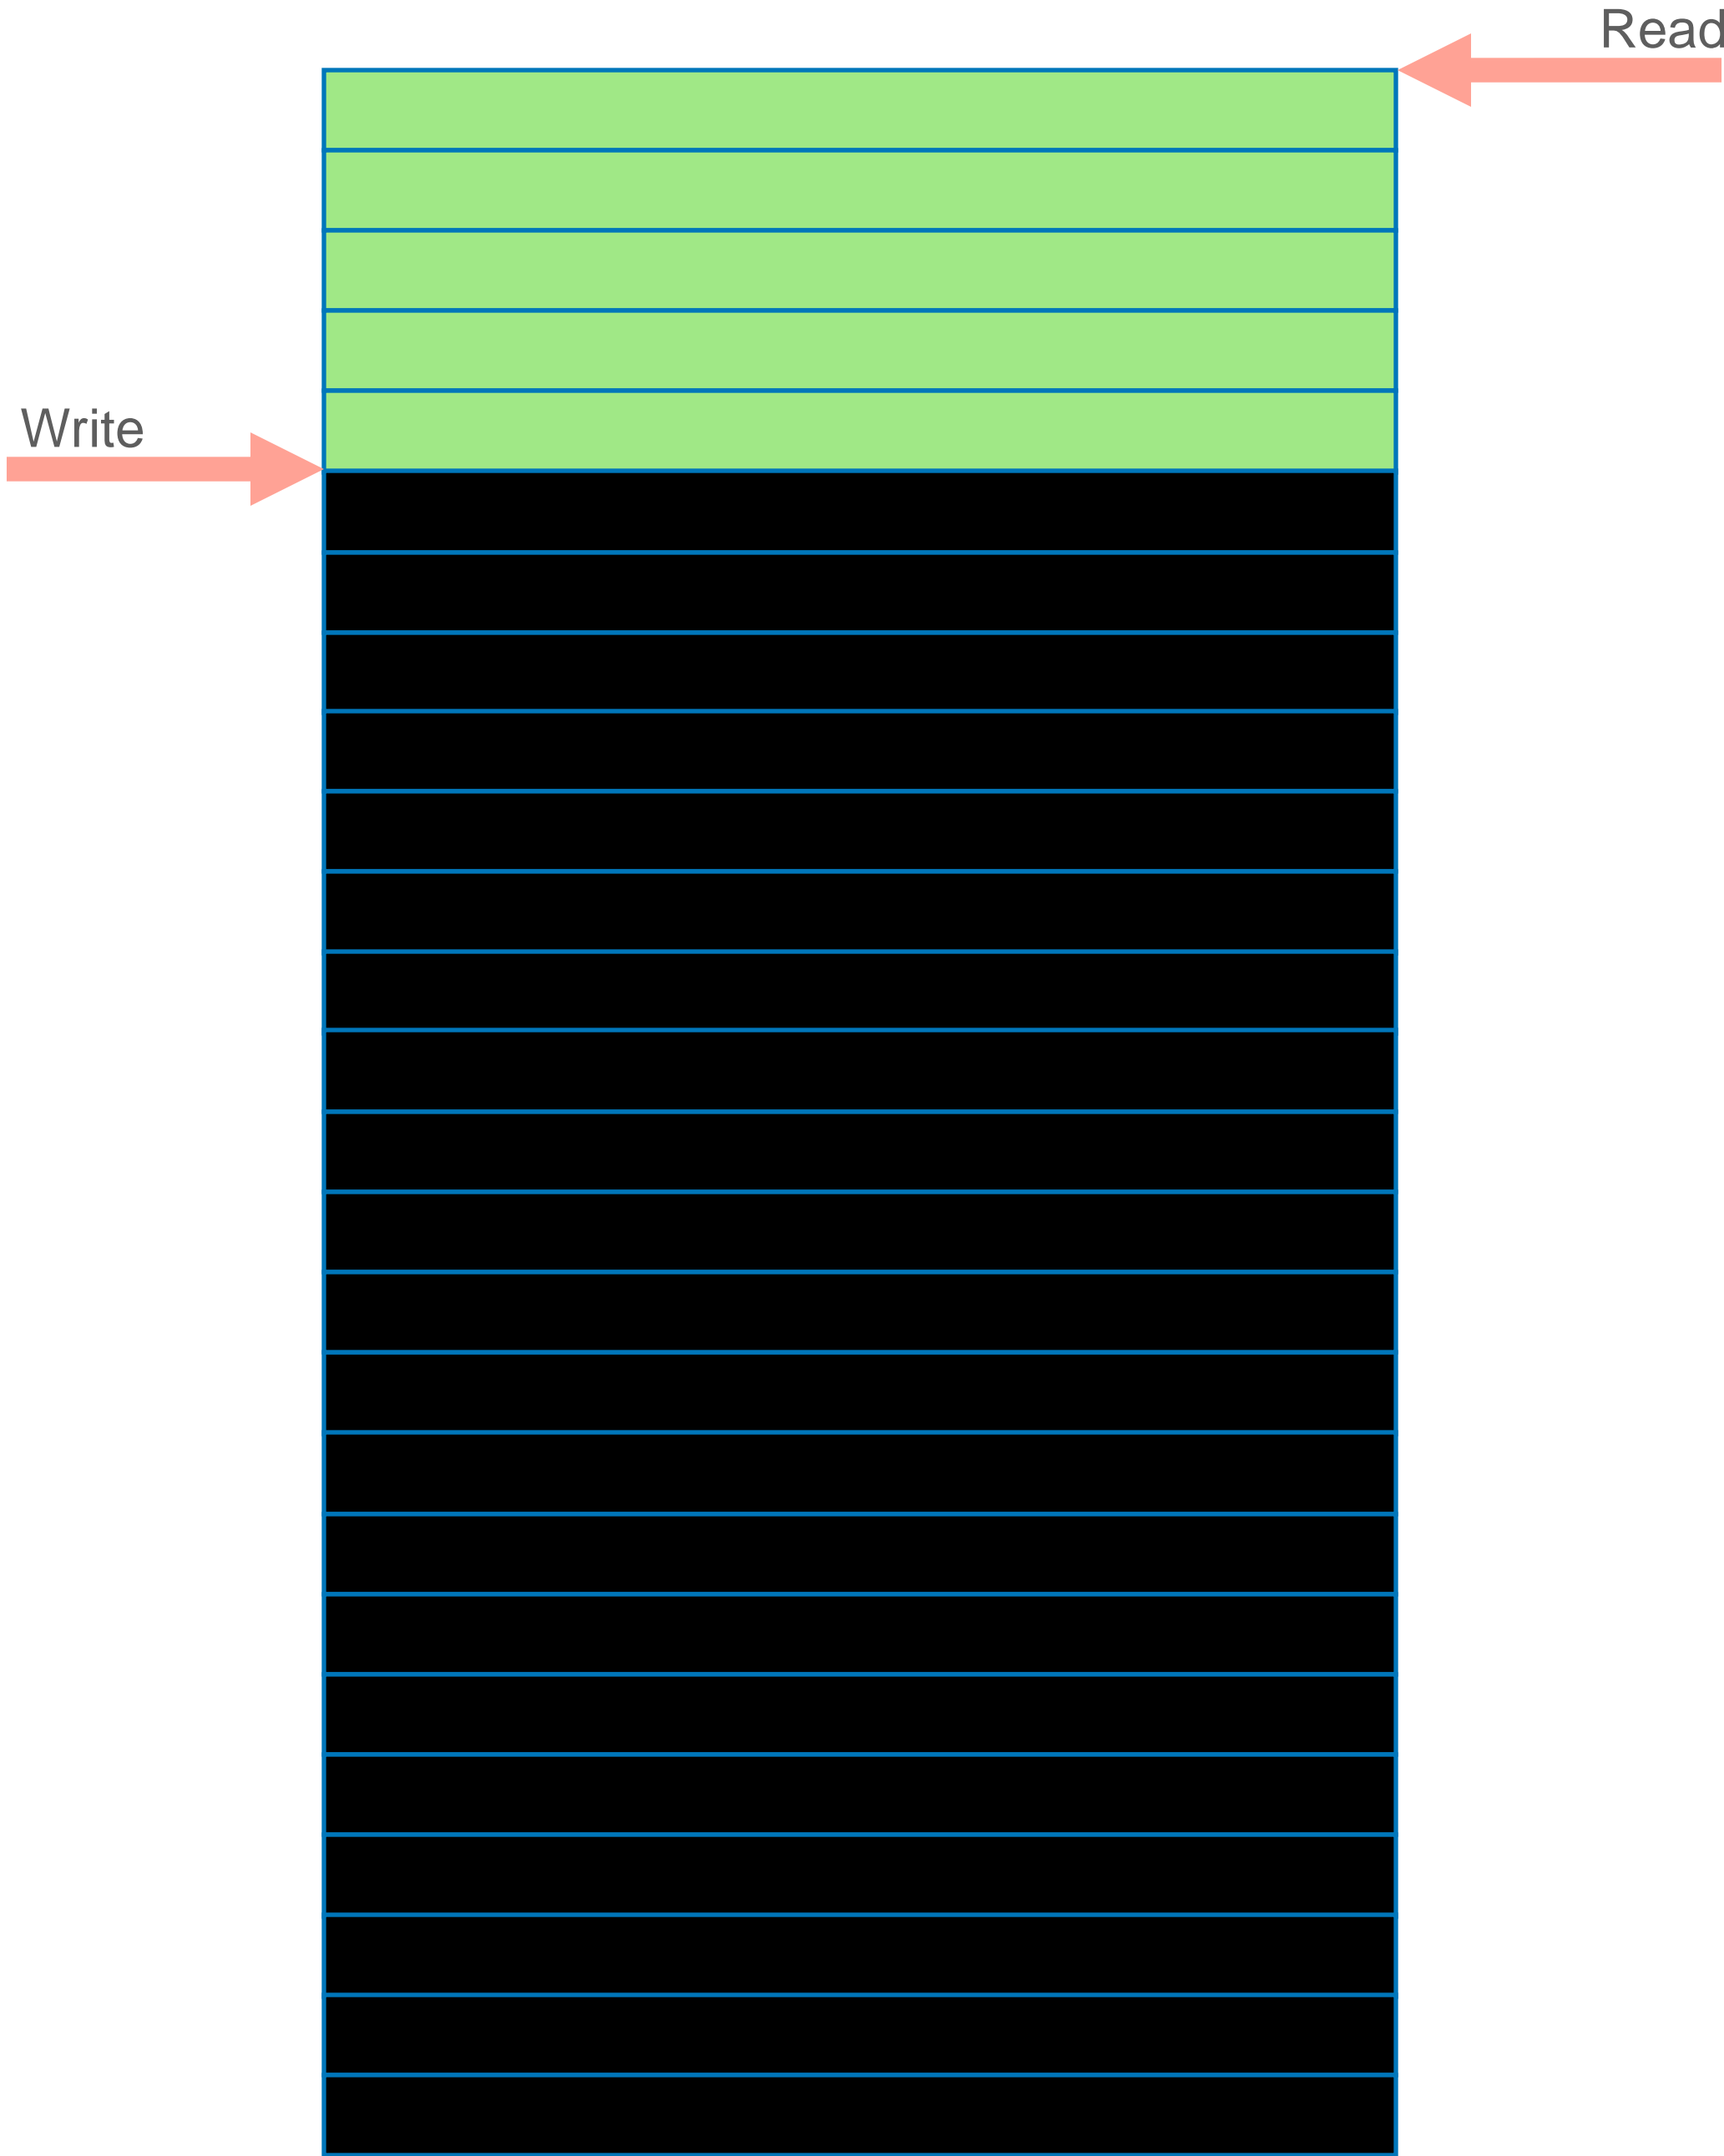
BRAM simplified schematic

- Data for an event is written to the BRAM upon reception

- Data for an event is written to the BRAM upon reception
- Data is read by PC as it is able to

- Data for an event is written to the BRAM upon reception
- Data is read by PC as it is able to
- If write rate greatly overwhelms the read rate...

- Data for an event is written to the BRAM upon reception
- Data is read by PC as it is able to
- If write rate greatly overwhelms the read rate...
- Data can be overwritten

- This can manifest as **dropped hits**, **unfinished event errors**, and “**expect new stream...**” data processor errors
- 64 bit chunks of data are missing from full event stream -> gives these kinds of errors
